BACKGROUND & POSITION PAPER
of
CHESAPEAKE UTILITIES CORPORATION
350 South Queen Street
Dover, Delaware 19901

Concerning
SUPERFUND REMEDIATION
of the
DOVER GAS LIGHT SITE

FEBRUARY, 1994

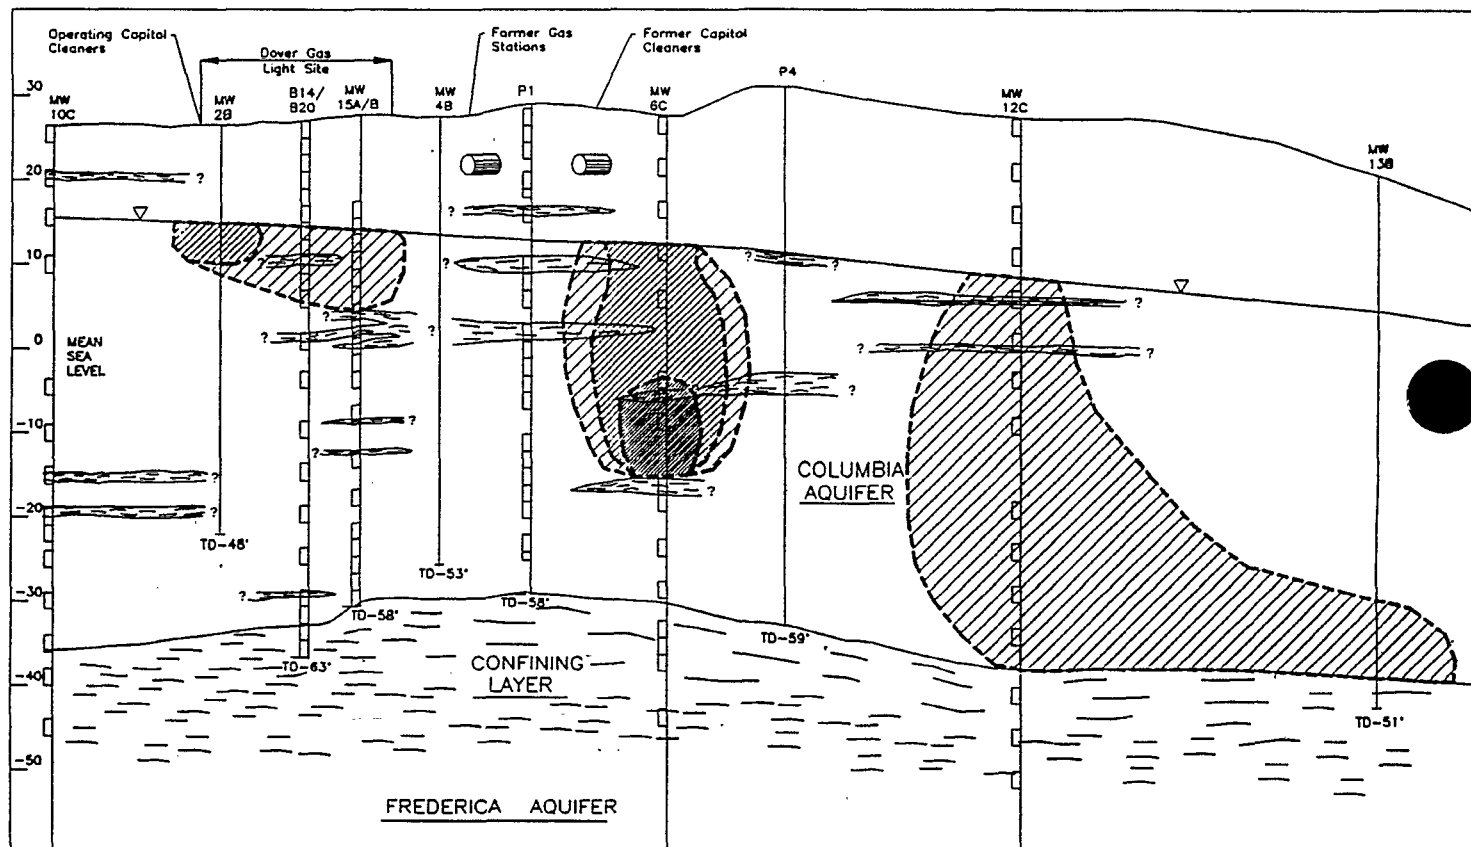
VERTICAL EXTENT OF CHLORINATED COMPOUNDS IN GROUND WATER

Shaded areas show estimates of where and how chlorinated solvents have spread into the Columbia aquifer just below the surface. The call-outs show location of dry cleaner and gas station tanks in relation to the Dover Gas Light Site.

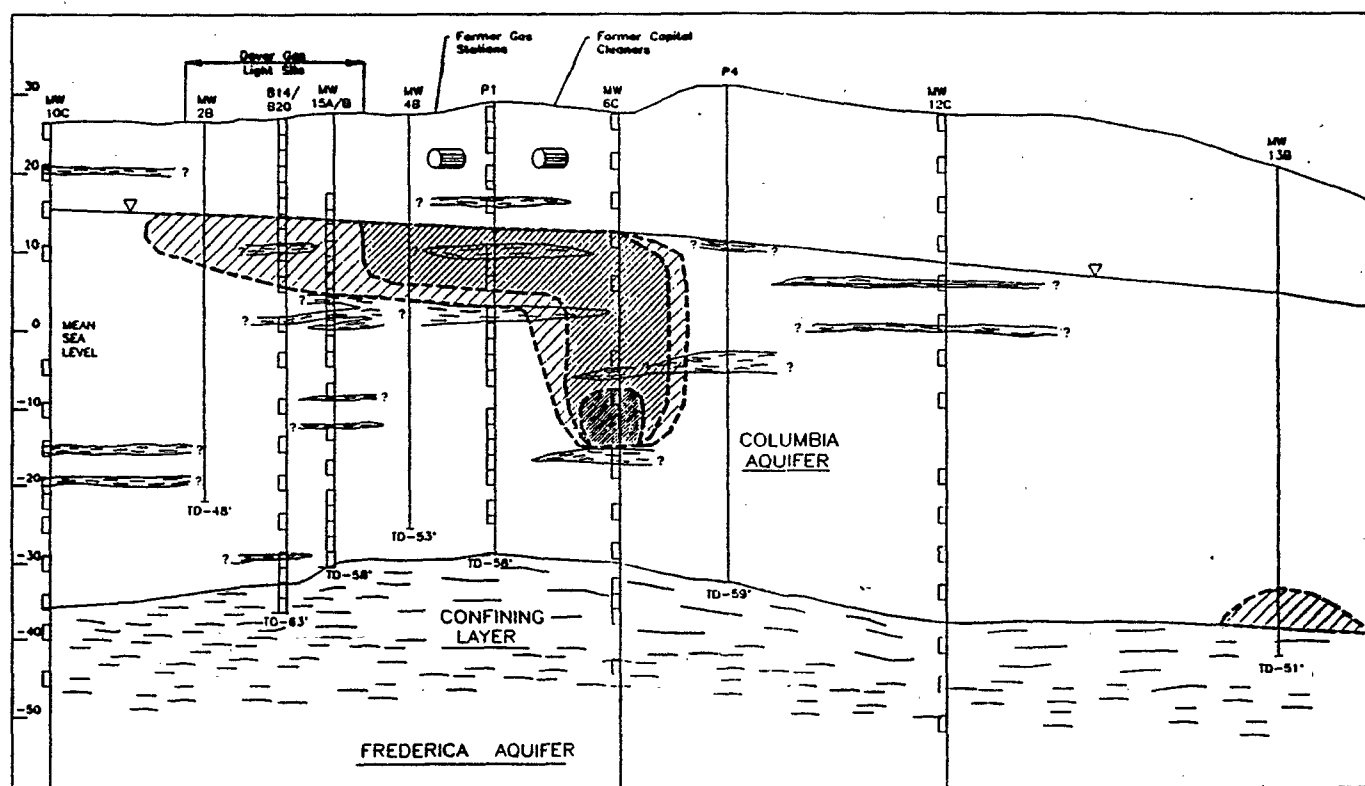
VERTICAL EXTENT OF PAHs IN COLUMBIA GROUND WATER

Impacts by Poly-Aromatic Hydrocarbons at left in drawing are combined result of Dover Gas Light Site and tanks owned by dry cleaners that have leaked. Result at right is from leaky State-owned tanks.

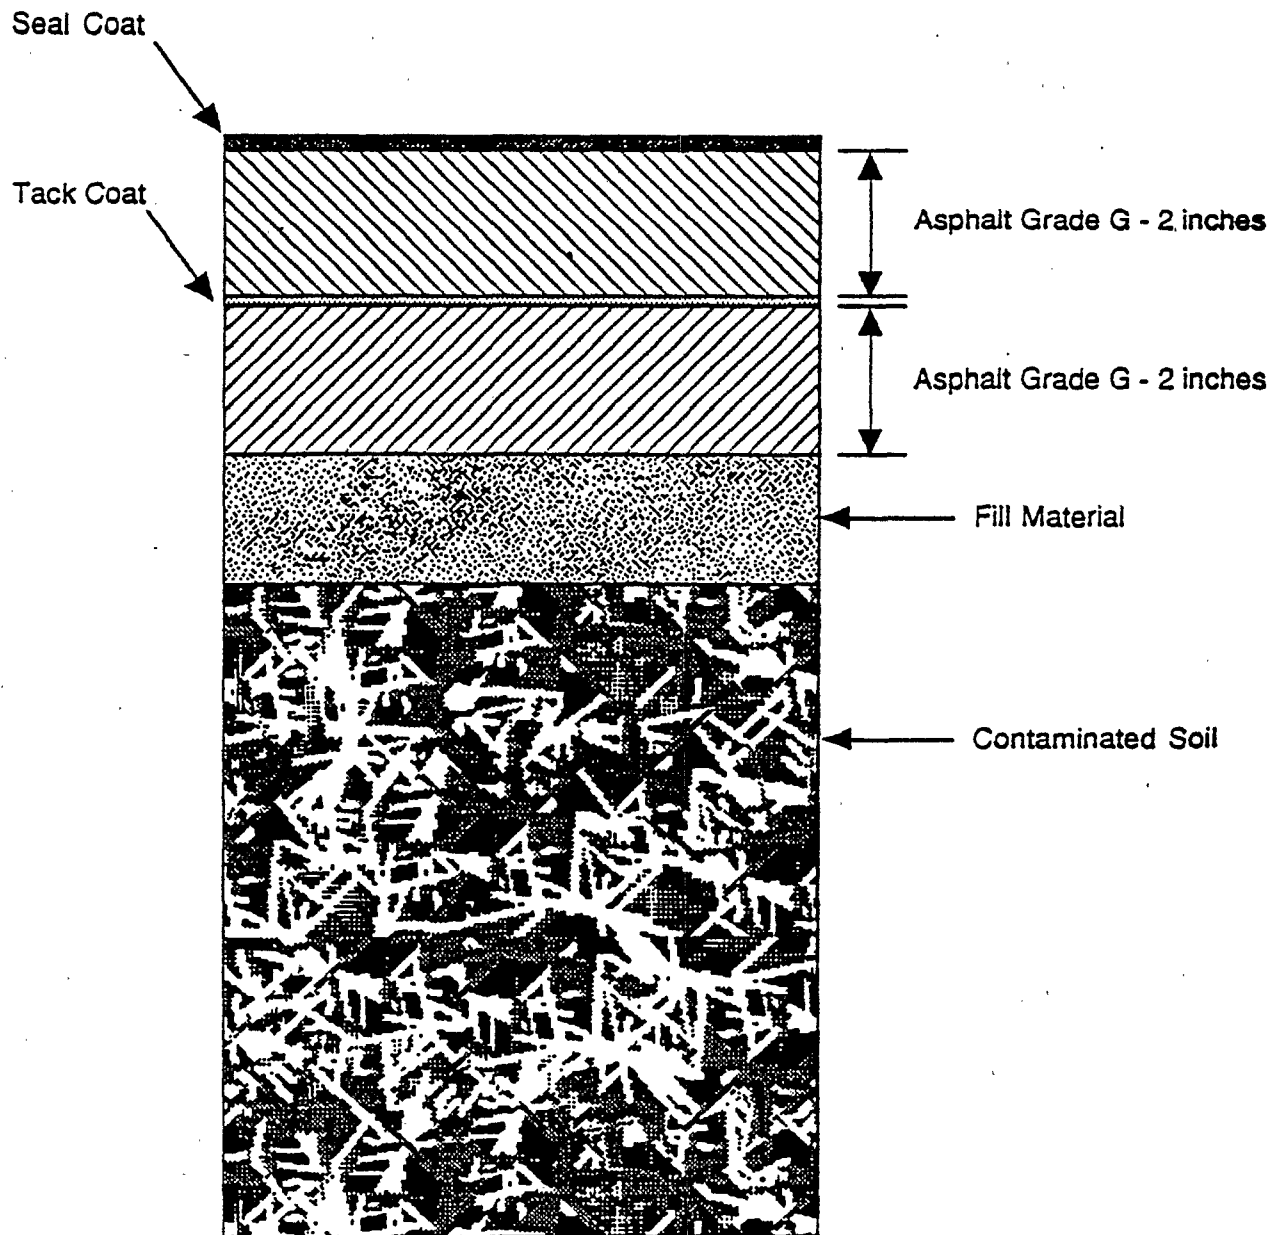
ASPHALT CAP DESIGN FOR DOVER GAS PLANT SITE

Sketch shows impenetrable seal that would be placed over the site to prevent rain water from leaching compounds off the site.

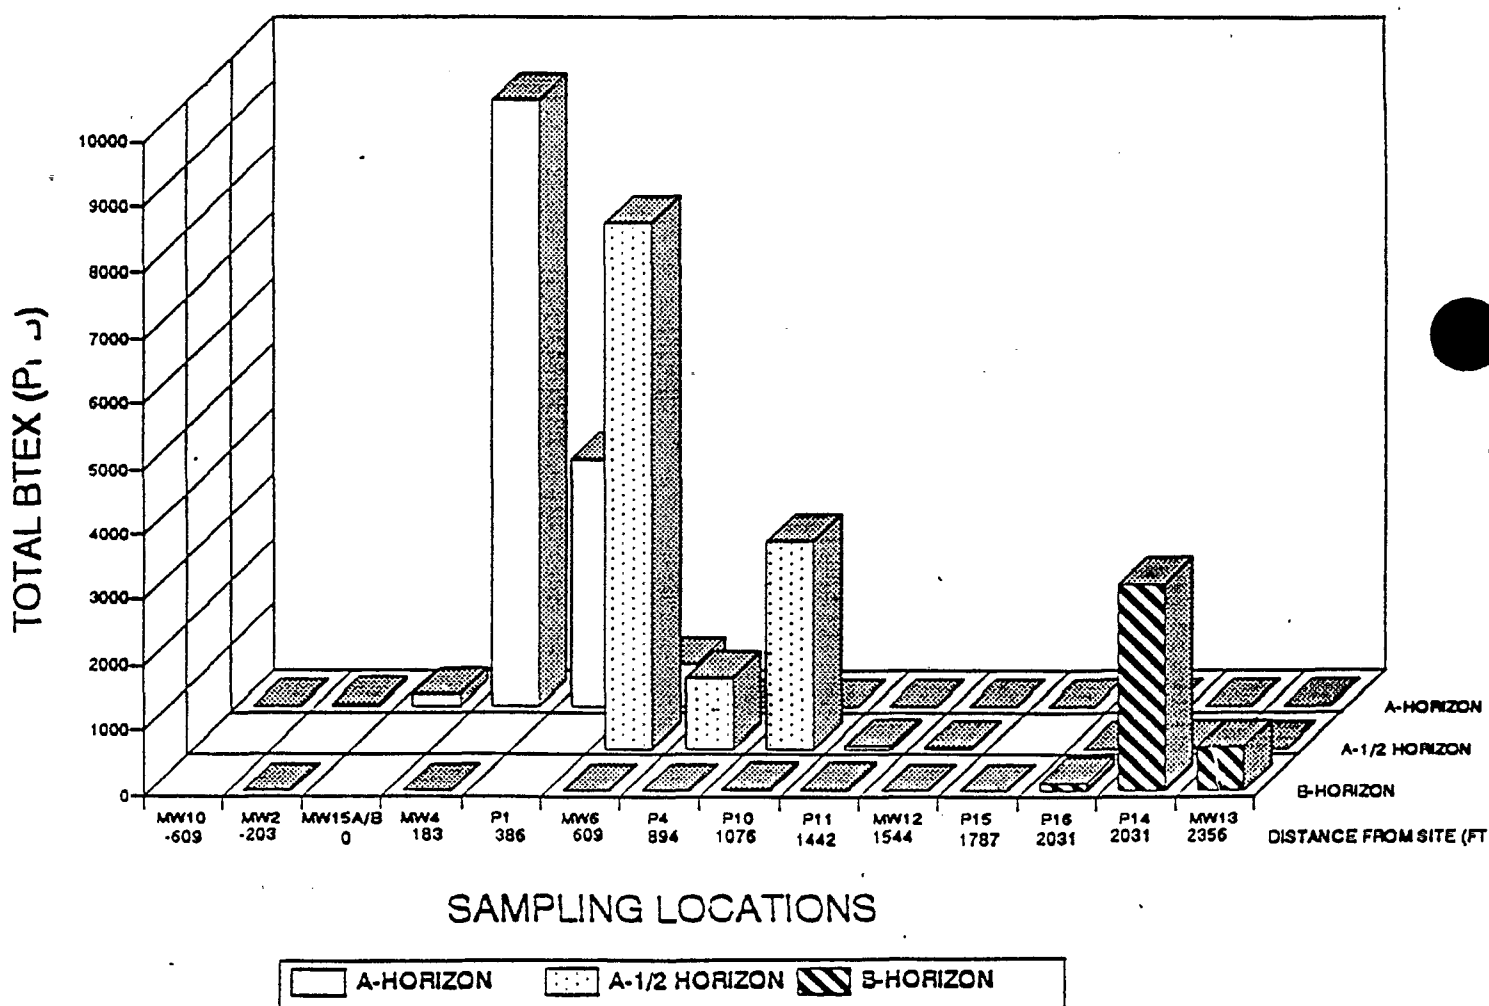
SPATIAL SEPARATIONS OF BTEX IN RELATION TO THE SITE

The spikes shown result from measurements at the differing locations east of the site at three different depths. They correspond to leaking tank locations at two different dry cleaning sites and three leaking tanks on State property. Results are from the Ground Water Phase III study.

SPATIAL DISTRIBUTION OF TOTAL BTEX

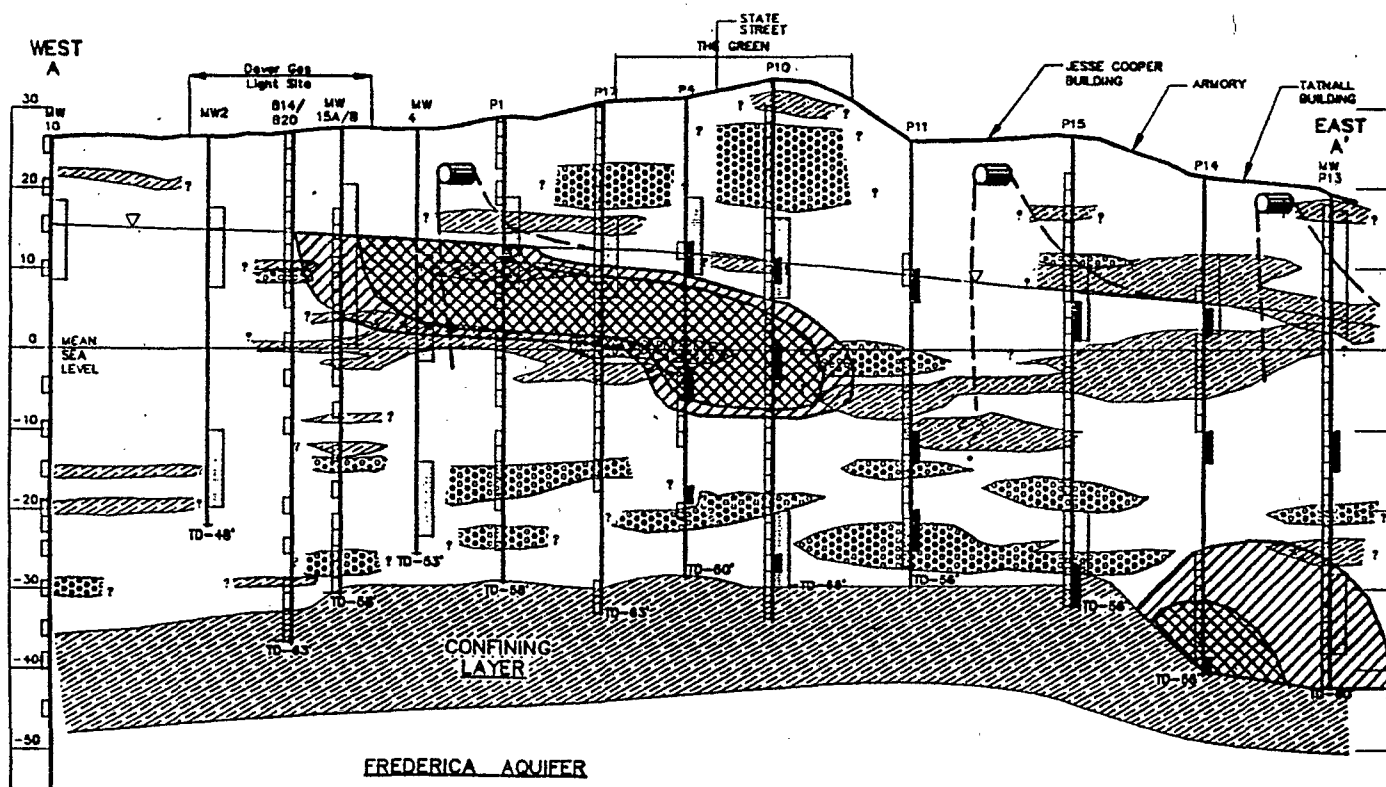
VERTICAL EXTENT AND SPACING OF BTEX IN GROUND WATER "A-A" HORIZON

Groundwater plumes show clear relationship to the site at left. The effects of dry cleaning fuel tanks and the result of leaking State fuel tanks are shown toward the right. Results are from the Ground Water Phase III study.

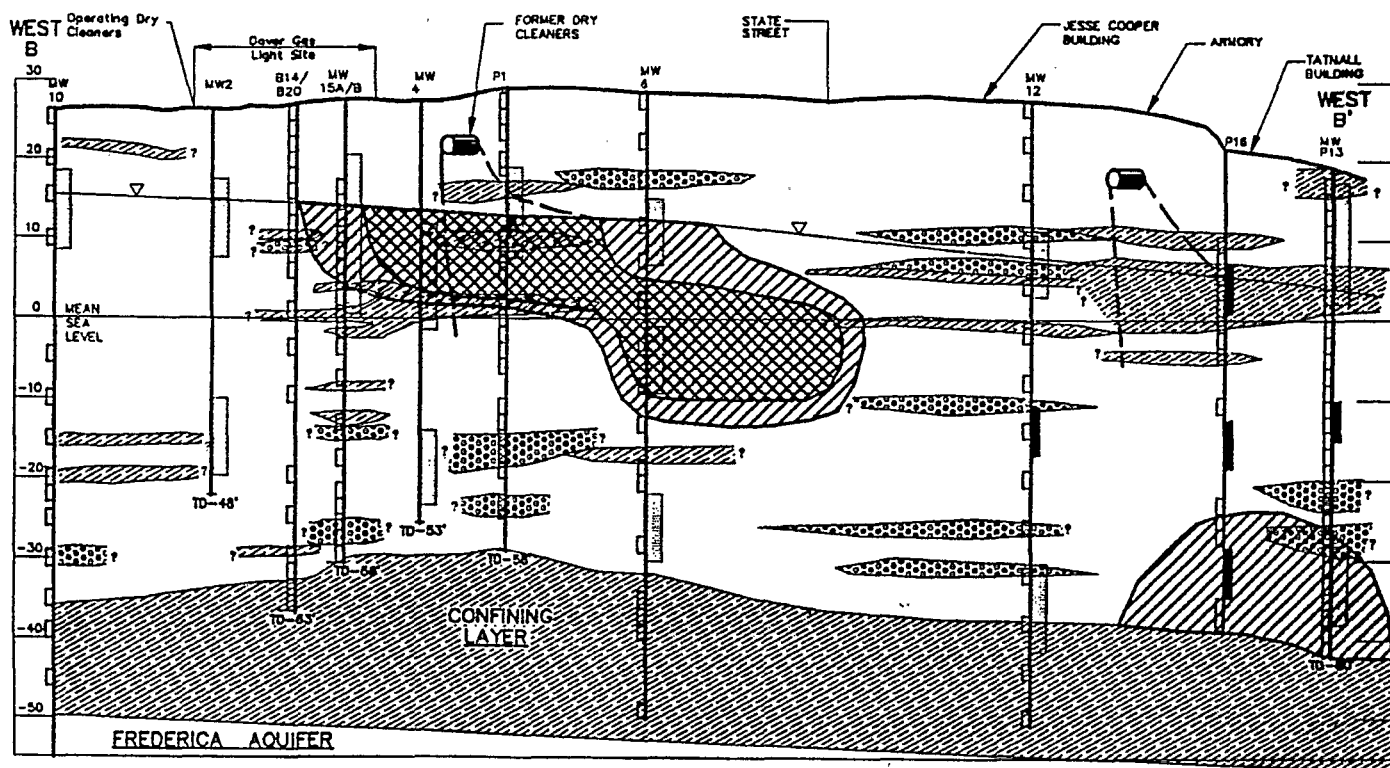
VERTICAL EXTENT AND SPACING OF BTEX IN GROUND WATER "B-B" HORIZON

Groundwater plumes show clear relationship to the site at left. The effects of dry cleaning fuel tanks and the result of leaking State fuel tanks are shown toward the right. Results are from the Ground Water Phase III study.

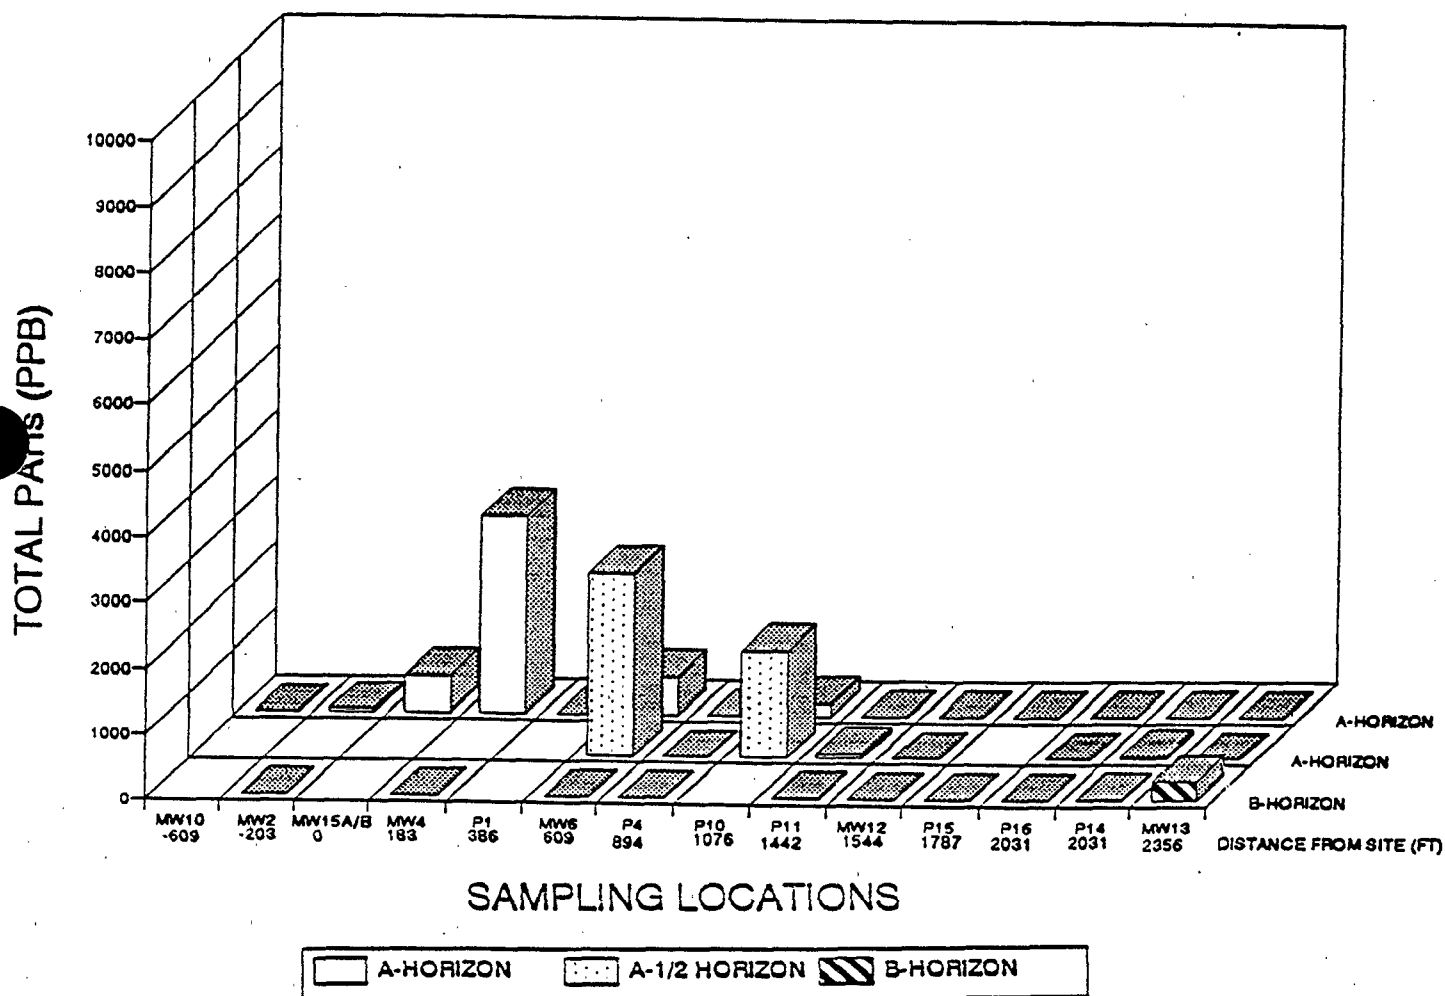
SPATIAL SEPARATIONS OF PAHs IN RELATION TO THE SITE

As with distribution of the BTEX contaminants, the spikes caused by presence of PAHs correspond to releases of fuel from the dry cleaning sites and, at right, to leaks from the State-owned tanks at three different depths. Results are from the Ground Water Phase III study.

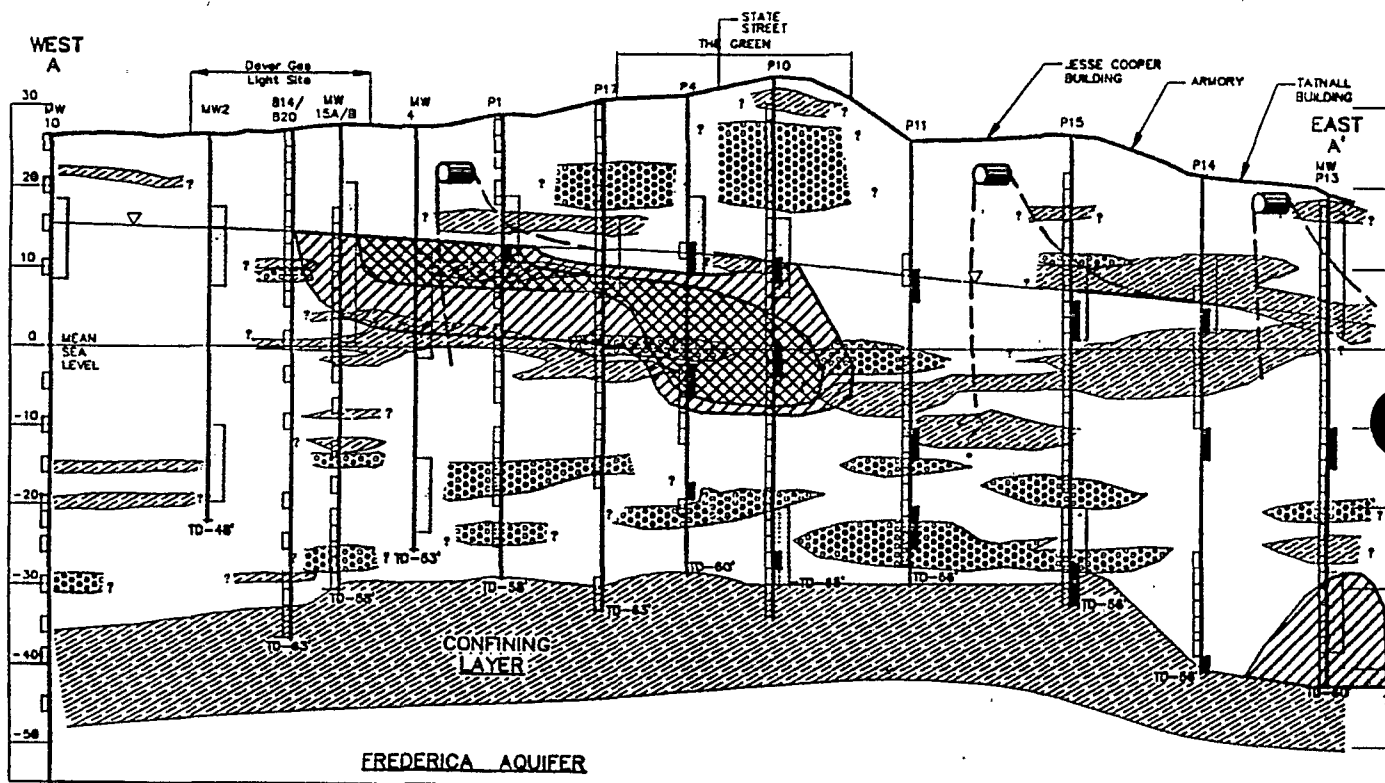
VERTICAL EXTENT AND SPACING OF PAHs IN GROUND WATER "A-A" HORIZON

Groundwater plumes show clear relationship to the site at left. The effects of the dry cleaning fuel tanks and the result of leaking State fuel tanks are shown toward the right. Results are from the Ground Water Phase III study.

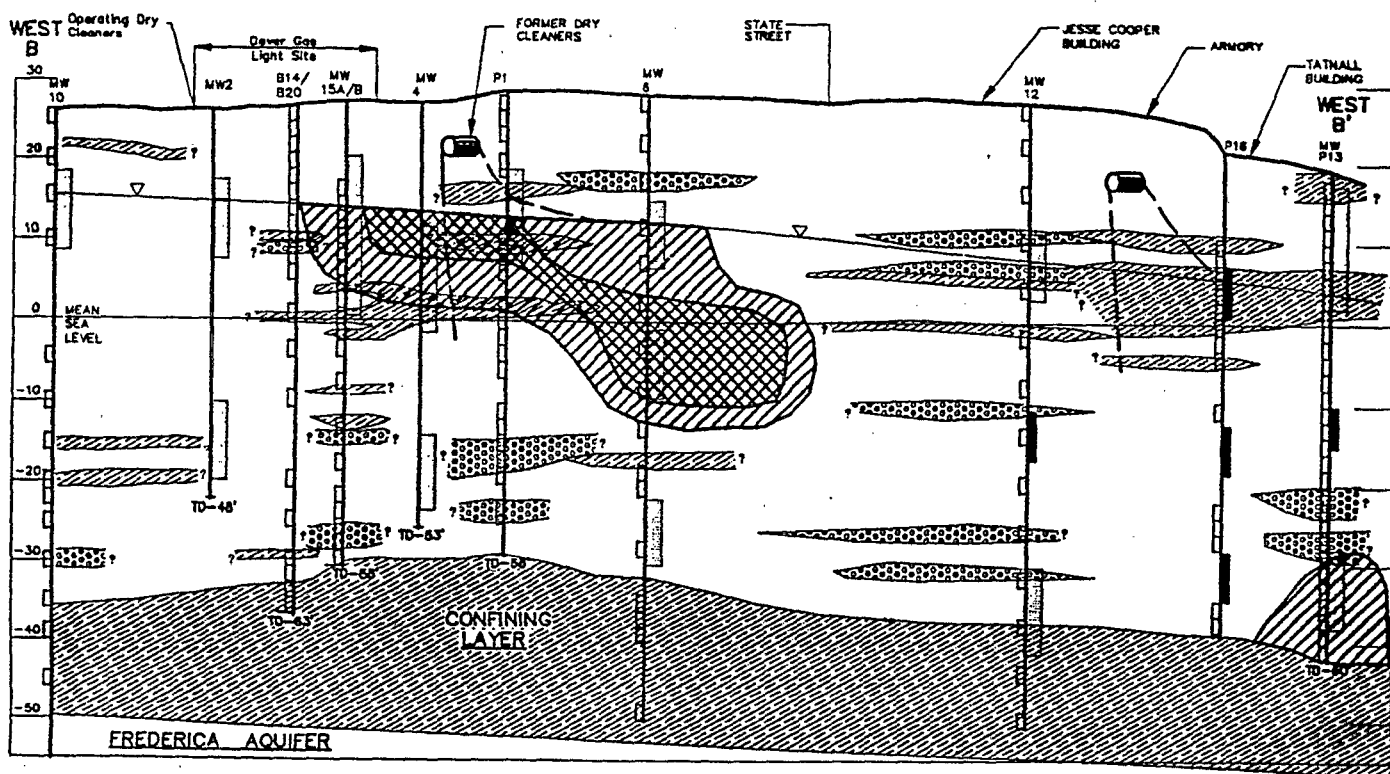
VERTICAL EXTENT AND SPACING OF PAHs IN GROUND WATER "B-B" HORIZON

Groundwater plumes show clear relationship to the site at left. The effects of the dry cleaning fuel tanks under The Green, and the result of leaking State fuel tanks are shown toward the right. Results are from the Ground Water Phase III study.

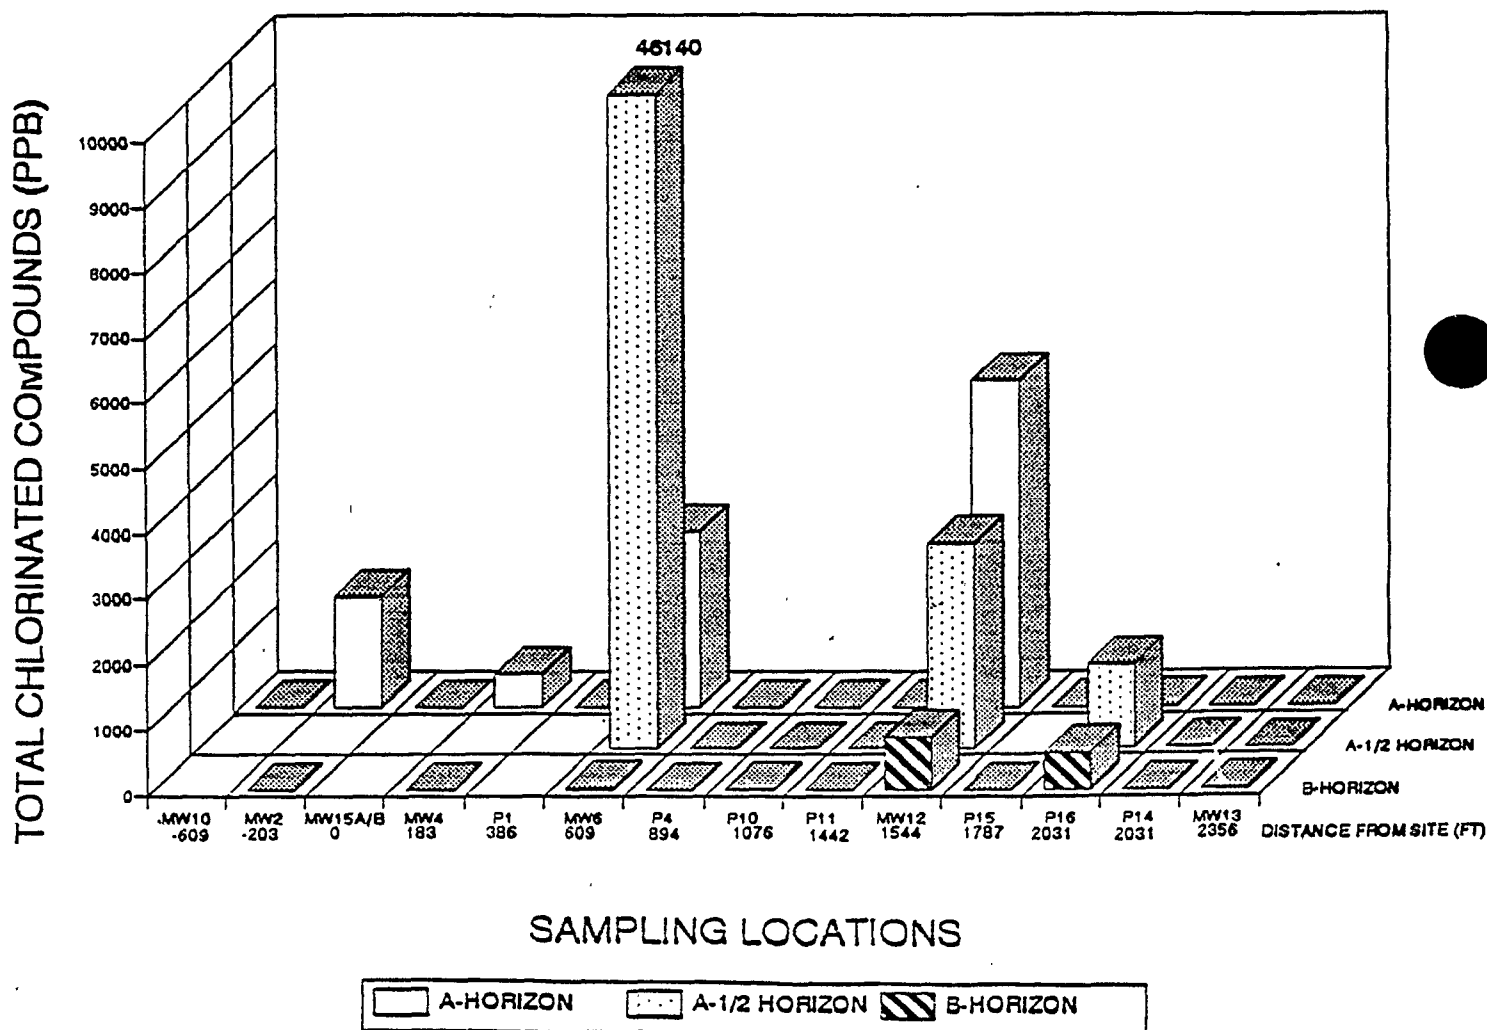
SPATIAL SEPARATION OF CHLORINATED COMPOUNDS

Spikes of chlorinated solvents show relationship to site, at left, as a result of dry cleaning solvent tank leaks. Spike shown on Dover Gas Light Site is coming from the existing dry cleaning site to the north. Larger spikes at center and right are the result of solvent leaks at the former drying cleaning site south and east of the Dover Gas Light Site. Solvent leaks have affected even the State properties at right. Measurements are from three horizons. Results are from the Ground Water Phase III study.

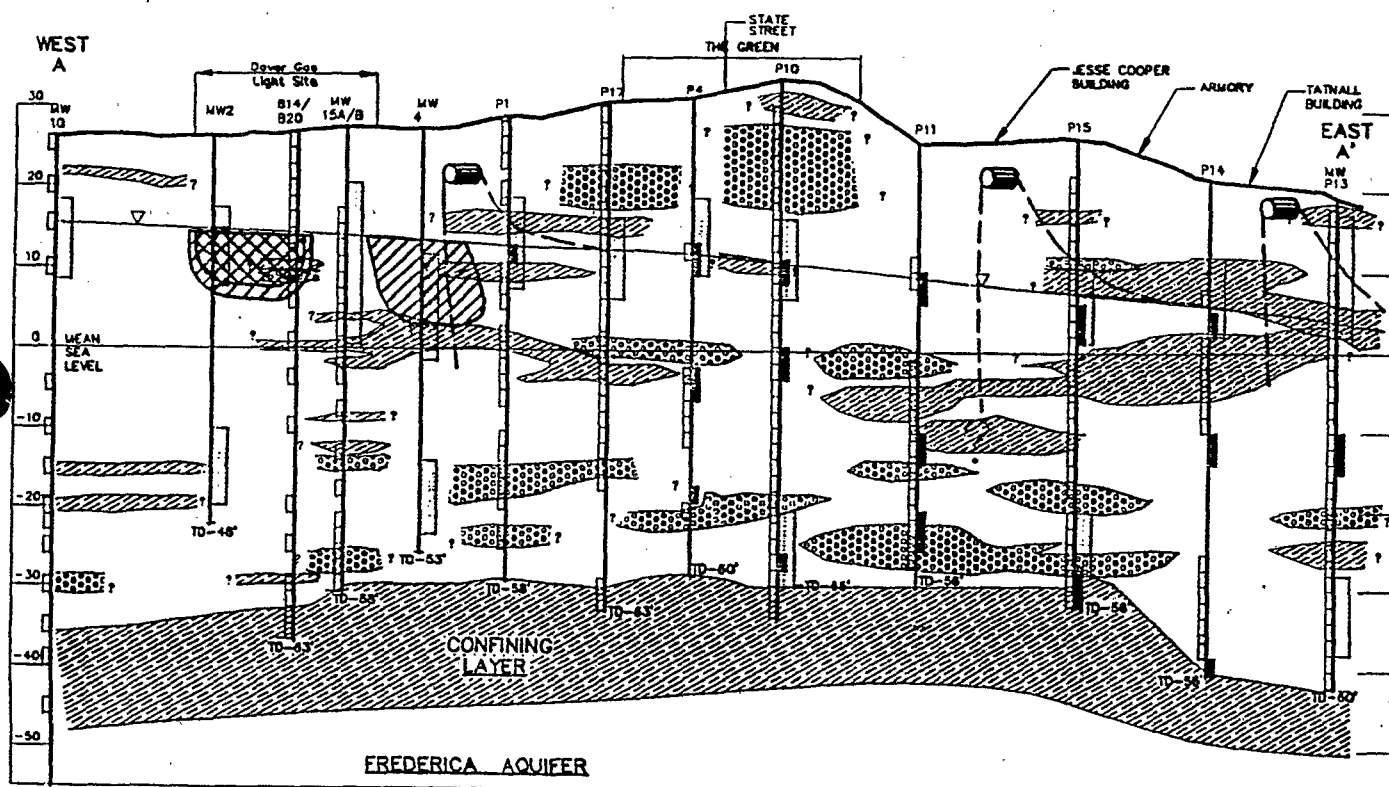
VERTICAL EXTENT AND SPACING OF CHLORINATED COMPOUNDS "A-A" HORIZON

Plume of chlorinated solvent under the Dover Gas Light Site comes from the existing location of the dry cleaners to the north. Plume of chlorinated solvent just east of the Dover Gas Light Site is from the former location of the dry cleaners. In this horizon, no solvent contamination is reaching under the State properties. Results are from the Ground Water Phase III study.

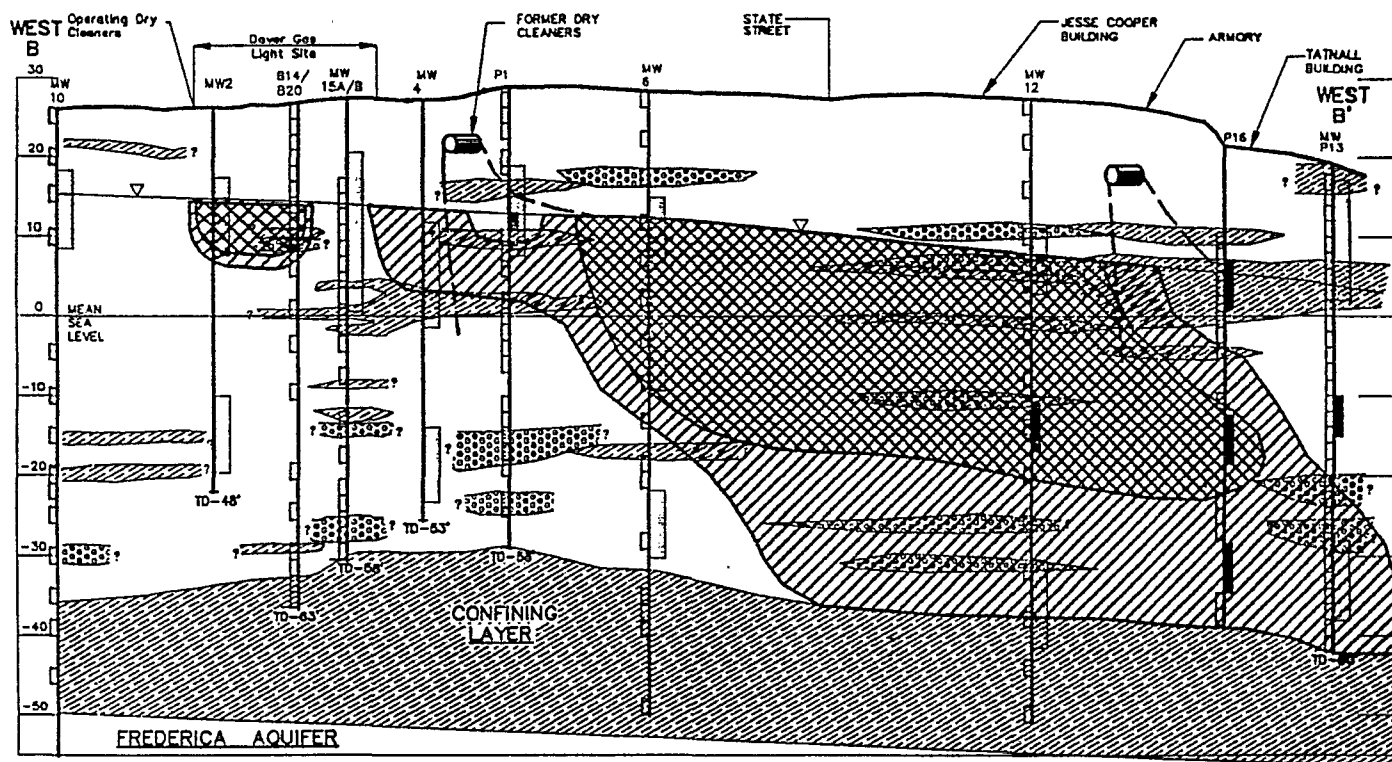
VERTICAL EXTENT AND SPACING OF CHLORINATED COMPOUNDS "B-B" HORIZON

In this horizon, plume of chlorinated solvent from the former dry cleaners location has affected almost all of the area east of the Dover Gas Light Site under the State properties. Results are from the Ground Water Phase III study.
